LEGIONELLA

RISK ASSESSMENT

Bursary

PREPARED BY : **ANDY WILKIE**
DATE : **10/03/2022**
CHECKED BY : **DONNA WELLBURN**

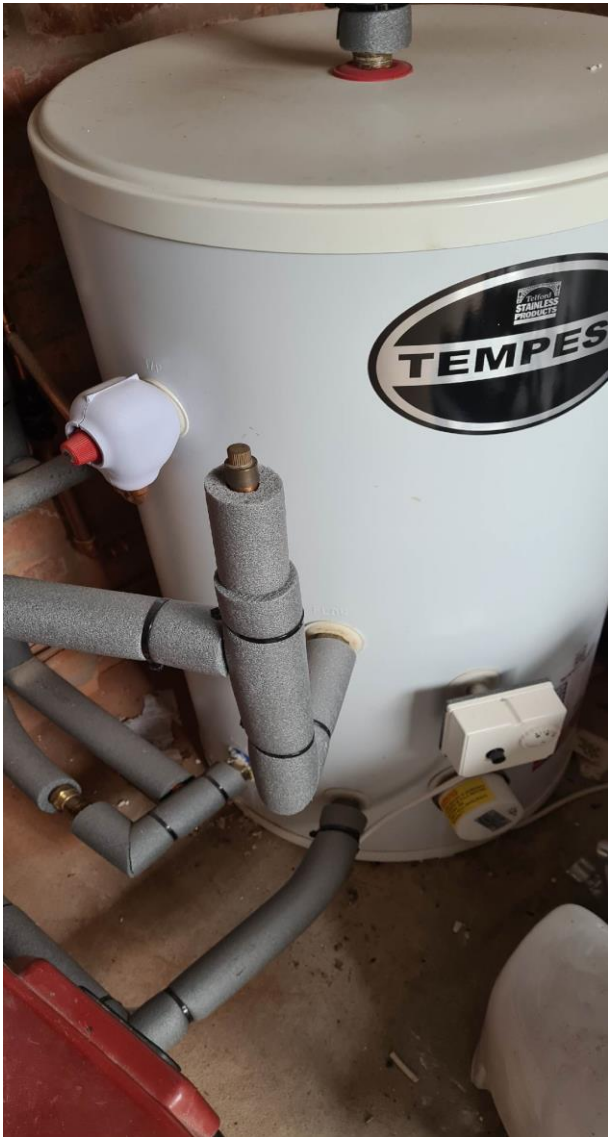
Calorifier Asset No	C. 1	C.2	C.3	C. 4	C.5
Location	<i>Plant Room</i>				
What does Calorifier Feed	<i>HWS</i>				
Construction (Copper/Galvanised)	<i>Stainles</i>				
Horizontal/Vertical	<i>Vertical</i>				
Source of Supply (Mains/Tank)	<i>Tank</i>				
Storage (Yes/No)	<i>Yes</i>				
Inspection Cover	<i>Yes</i>				
Temperature	<i>56.8</i>				
Return Temperature	<i>52.2</i>				
Calorifier Set Point Temperature	<i>60.0</i>				
Base Temperature	<i>52.0</i>				
Condition of Insulation	<i>Good</i>				
Physical Dimensions (Height/Diameter)	<i>600 x 800</i>				
Inspection Hatch (Yes/No)	<i>Yes</i>				
Can Unit be Isolated?	<i>Yes</i>				
Secondary Return (Yes/No)	<i>Yes</i>				
Return Pump (Single/Duplex)	<i>Single</i>				
Anti-Stratification Pump (Yes/No)	<i>Yes</i>				
Total base flushing possible (Yes/No)	<i>Yes</i>				
Position of Drain Off Cock	<i>Bottom</i>				
Diameter Drain-off Cock	<i>22mm</i>				
Pressure Gauge (Yes/No)	<i>Yes</i>

The calorifiers are in very good condition.
