# LEGIONELLA

## RISK ASSESSMENT

### Old School House

**DATE : 10.03.22**

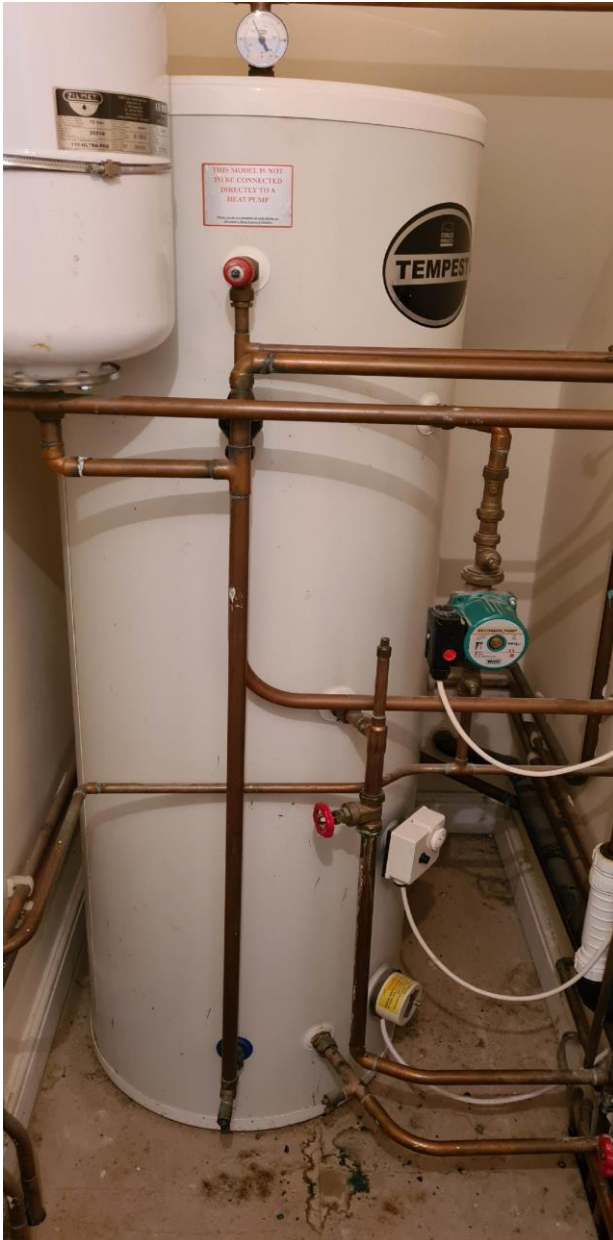
**Calorifier**

The calorifier is in very good condition.

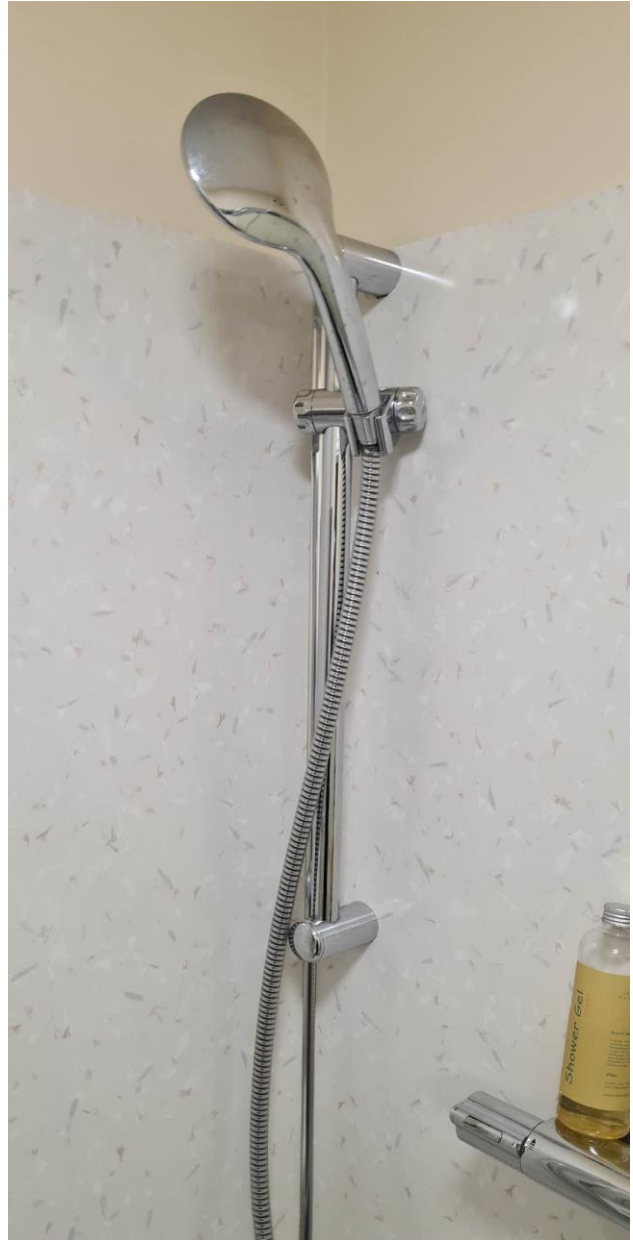
**Old School Shower**

| <i>Description</i> | <i>Location</i> | <i>Material</i> | <i>Compliance<br/>Yes/No</i> | <i>Risk<br/>High/Med/Low</i> |
|---|---|---|---|---|
| Showers | Yes | Brass | Yes | Med |
